Technical Report
Palm Beach Lakes Community High School ROV Team
West Palm Beach, FL

2009 MATE International ROV Competition
ROV Submaris Eripio
Explorer Class

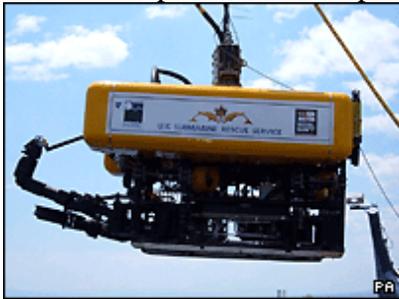
Scorpio ROV - Scorpio 45

The United Kingdom operates ROV **Scorpio 45**, which is based at the UK's Submarine Rescue Service headquarters in Renfrew (near Glasgow, Scotland). It carries three remote cameras, two manipulator arms (including cutting equipment) and two sonar devices, as well as six 250-W lights. It is capable of operating at a depth of 925m (in sea water), with the depth being determined by the length of its umbilical cable. Scorpio 45 may also travel at a forward speed of up to 4 knots. The ROV is owned by the UK Ministry of Defense and is operated by James Fisher Rumic Ltd, who provides the rescue service to the Ministry. The vehicle is deployed along with a control room which is within a standard shipping container. The vehicle's primary role is to assist in locating a distressed submarine, survey the damage, clear obstructions from the escape hatches and then transfer life support stores in special containers via the submarine's escape hatch. Scorpio 45 was extensively modified to support manned submarine emergency and rescue facilities. James Fisher Rumic Ltd took over ownership of the ROV after reaching agreement with the Ministry of Defense's Disposal Services Agency in November 2006 to acquire the operating assets of the UK Submarine Rescue Service.
